Belzona: Stops Leaks in Cooling Towers

Industry: Power
Application: HEX-Heat Exchangers
Substrate: Concrete
Products: * Belzona® 2211 (MP Hi-Build Elastomer) ,
* Belzona® 2221 (MP Fluid Elastomer) ,

Customer Location: Power Plant in South Texas
Application Date: March 2005

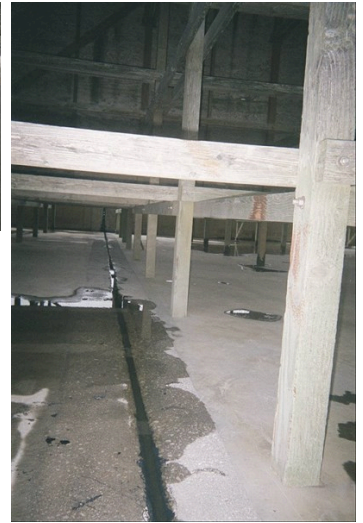
Leaking water was causing economic concerns. The old joint sealants had worn down and ground movement caused leaks in the concrete floor and walls.

- * Cooling tower ,
- * Expansion joints being prepared ,
- * Belzona® 2221 being poured into backed joints ,
- * Finished joint holds back rainwater ,

The application was carried out in accordance with Belzona Know-How System Leaflet HEX-13b.
