Belzona: Stops Leaks in Cooling Towers

Industry: Power
Application: HEX-Heat Exchangers
Substrate: Concrete
Products: * Belzona® 2211 (MP Hi-Build Elastomer) ,
* Belzona® 2221 (MP Fluid Elastomer) ,

Customer Location: Power Plant in South Texas
Application Date: March 2005

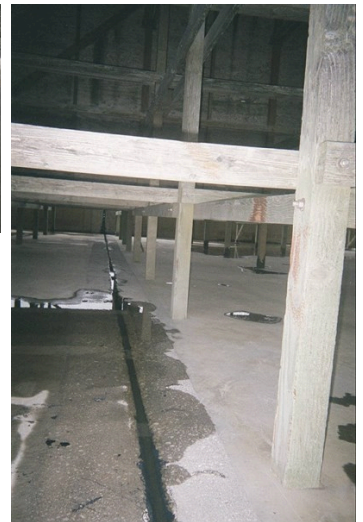
Leaking water was causing economic concerns. The old joint sealants had worn down and ground movement caused leaks in the concrete floor and walls.

- * Cooling tower ,
- * Expansion joints being prepared ,
- * Belzona® 2221 being poured into backed joints ,
- * Finished joint holds back rainwater ,

The application was carried out in accordance with Belzona Know-How System Leaflet HEX-13b.

Belzona's elongation and superior adhesion characteristics were demonstrated using bricks. Client selected Belzona based on product capabilities, Belzona Know-How and excellent local service. Alternative considered was a spray on urethane system that did not have the desired elongation.
