# BELZONA REPAIRS BUTTERFLY VALVE GASKET

ID: 5280

**Industry:** General Industry  
**Application:** GSS-Gaskets, Seals and Shims  
**Substrate:** Cast Iron and Steel  
**Products:** \* Belzona 2131 (D & A Fluid Elastomer) ,

**Customer Location:** MO, USA  
**Application Date:** September 2006

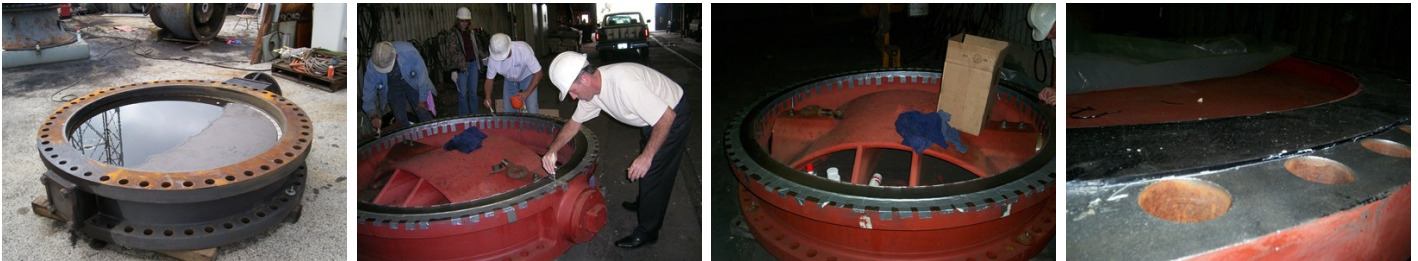
The butterfly valve from the main circulating water system of the power plant was removed for maintenance and required a new gasket prior to reinstallation.

- \* Blasted butterfly valve gasket ,
- \* Application of product ,
- \* Finished repair ,
- \* Close-up of gasket prior to installation ,

The customer scheduled a maintenance outage to build the gasket with the Belzona elastomer for the butterfly valve to prevent delay with reinstalling.

The application was carried out in accordance with Belzona Know-How System Leaflet GSS-1 using Belzona 2131. After grit blasting the surface, heavy gauge wire was used to form a channel to apply Belzona 2131 to the proper thickness.
