BELZONA REBUILDS CONVEYOR DRIVE SHAFT IN PLACE

ID: 5282

Conveyor drive shaft

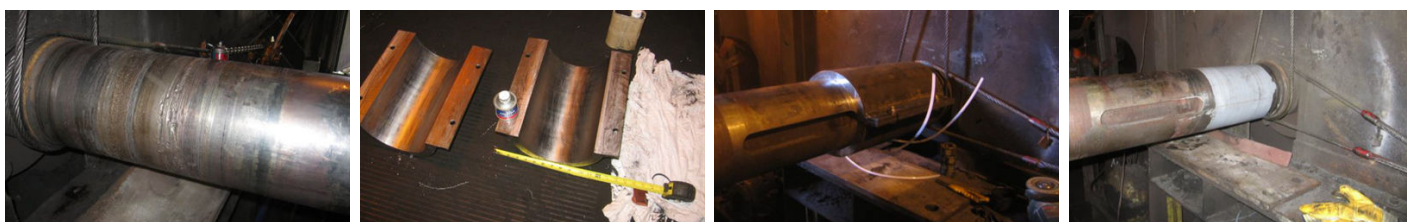
Photograph Descriptions

This 8" diameter shaft carries the head pulley of a large conveyor belt. The bearing seat on the drive end was heavily scored worn more than 1/4" undersize.

- * Damaged bearing seat ,
- * Split mould coated with release agent ,
- * Mould clamped on shaft with injection tubes in place ,
- * Shaft with repaired bearing seat ready for service ,

The application was carried out in accordance with Belzona Know-How System Leaflet MPT-2. A split mould was machined to size, and coated with mould release agent. The seat area on the shaft was prepared with an angle grinder, and the mould clamped in place. Then Belzona 1321 was mixed and injected into the mould. When the mould was removed, the cured Belzona material forms a new bearing seat.
