BELZONA REBUILDS ERODED KEEL COOLER

ID: 5283

Industry: *Marine*
Application: *SOS-Ships and Offshore Structures*

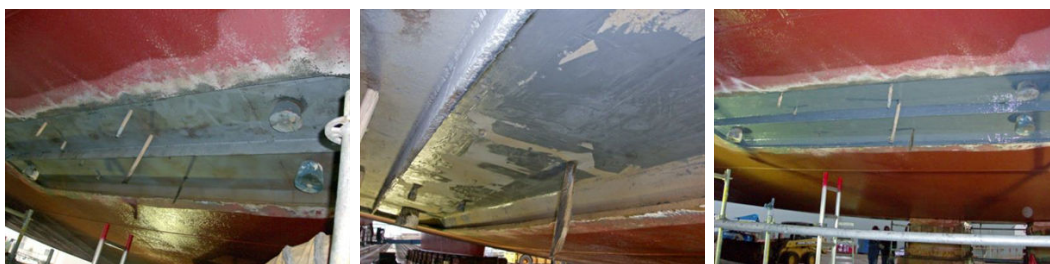
Photograph Descriptions

The keel cooler metal was suffering from corrosion pitting.

- * View of corrosion. ,
- * Corroded and pitted areas rebuilt. ,
- * Completed application. Entire cooler surface protected. ,

The application was carried out in accordance with Belzona Know-How System Leaflet SOS-1 and SOS-2.

As a leader in corrosion resistance coatings, Belzona repair materials are approved by many marine specifying authorities. Belzona 1311 rebuilt the keel cooler and Belzona 1321 protected the surface. Belzona provides an extend life time service for the keel cooler.
