# Conveyor Belt Repair Saved Coal Terminal Dollars and Downtime!

ID: 5286

Industry: Marine  
Application: SHM-Solids Handling Machinery

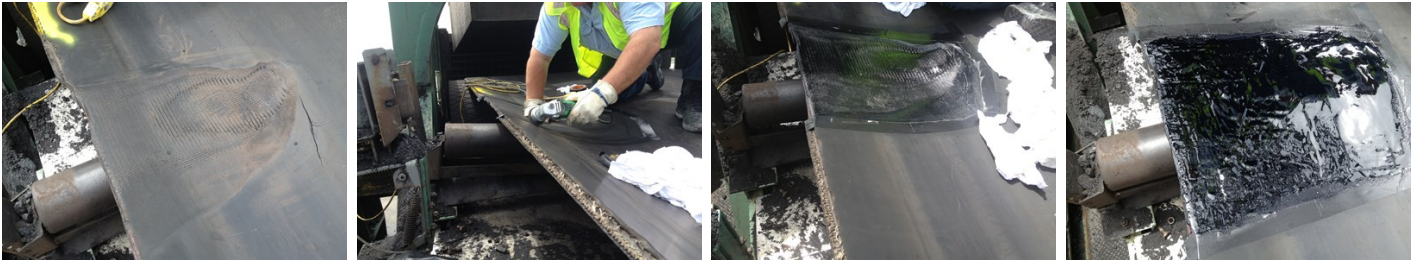
## Photograph Descriptions

- \* 1. Damaged belt ,
- \* 2. Technician preparing the repair area ,
- \* 3. Belzona 2911 applied; Ready for Belzona 2111 and Belzona 2121 and tape ,
- \* 4. Application completed ,

2' x 2' sq area was heavily damaged by the belt catching on roller.

Belt was prepared using grinder and roughing brush. Belzona 2911 applied and dried to touch. Belzona 2111 applied to surface. Reinforcement sheet impregnated with Belzona 2121 and placed across repair area. Application was carried out in accordance with a modified version of Belzona Know-How System Leaflet SHM-1.
