# Belzona Performs a Classic Repair

**Industry:** General Industry  
**Application:** ENC-Engines and Casings  
**Substrate:** Cast Iron  
**Products:** \* Belzona® 1111 (Super Metal) ,  
\* Belzona® 9341 (Reinforcement Tape) ,

**Customer Location:** Motor Enthusiast, Cheshire, England  
**Application Date:** April 2005

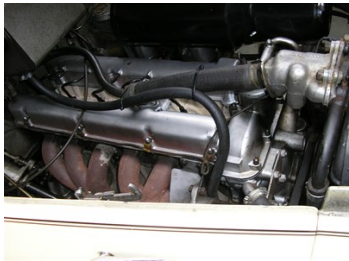
A small crack had developed in the 2.8 litre engine casing of this 1951 David Brown Lagonda.

- \* The engine block ,
- \* The exterior of this fully restored classic car ,
- \* The cars interior ,
- \* The rear view of the car ,

Application was carried out in accordance with Belzona Know-How System Leaflet ENC-1.

Belzona was chosen as being the quickest, simplest and cheapest method of conducting the repair. Other alternatives would have involved welding, which the client did not want to pursue due to the age of the casting. The repair needed to be carried out quickly as the car was to go on show the following day. The total cost was around £15 (\$28) to complete.
