# Belzona Performs a Classic Repair

**Industry:** General Industry  
**Application:** ENC-Engines and Casings  
**Substrate:** Cast Iron  
**Products:** \* Belzona® 1111 (Super Metal) ,  
\* Belzona® 9341 (Reinforcement Tape) ,

**Customer Location:** Motor Enthusiast, Cheshire, England  
**Application Date:** April 2005

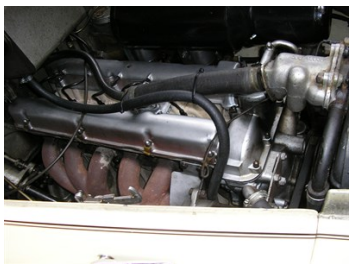
*A small crack had developed in the 2.8 litre engine casing of this 1951 David Brown Lagonda.*

- \* The engine block ,
- \* The exterior of this fully restored classic car ,
- \* The cars interior ,
- \* The rear view of the car ,

Application was carried out in accordance with Belzona Know-How System Leaflet ENC-1.

Belzona was chosen as being the quickest, simplest and cheapest method of conducting the repair. Other alternatives would have involved welding, which the client did not want to pursue due to the age of the casting. The repair needed to be carried out quickly as the car was to go on show the following day. The total cost was around £15 (\$28) to complete.
