Belzona Performs a Classic Repair

A small crack had developed in the 2.8 litre engine casing of this 1951 David Brown Lagonda.

Engine casing on vintage car

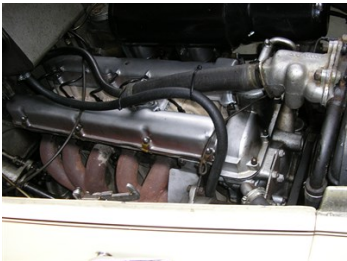
- * The engine block ,
- * The exterior of this fully restored classic car ,
- * The cars interior ,
- * The rear view of the car ,

Application was carried out in accordance with Belzona Know-How System Leaflet ENC-1.

Belzona was chosen as being the quickest, simplest and cheapest method of conducting the repair. Other alternatives would have involved welding, which the client did not want to pursue due to the age of the casting. The repair needed to be carried out quickly as the car was to go on show the following day. The total cost was around £15 (\$28) to complete.
