# BELZONA REBUILDS ERODED TUBE SHEET BASE

**Industry:** Heating, Ventilation & Air Conditioning  
**Application:** HEX-Heat Exchangers  
**Substrate:** Mild Steel  
**Products:** \* Belzona 1391 (Ceramic HT) ,

**Customer Location:** BC, Canada  
**Application Date:** October 2010

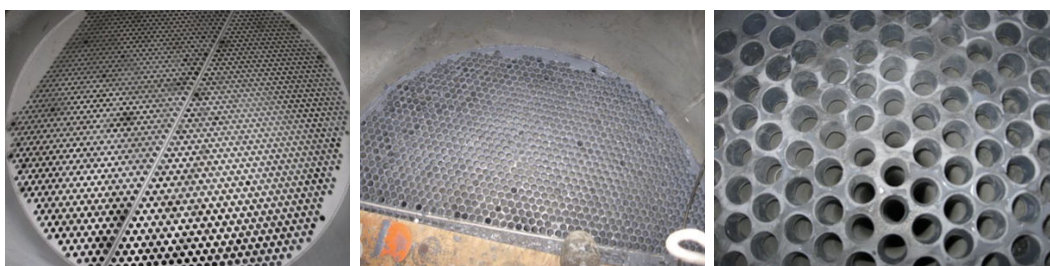
## Photograph Descriptions

- \* The tube sheet was grit blasted to a near white metal finish leaving a blast profile of approximately 3 mil. ,
- \* The EPDM plugs were inserted into each of the 2300 holes and levelled off with a straight edge. Belzona 1391 was injected into the space around the EPDM plugs to a depth of  $\frac{3}{4}$  inch in places. ,
- \* The EPDM plugs were removed after the material cured, leaving a smooth Thconical hole. ,

The application was carried out in accordance with a modified Belzona Know-How System Leaflet HEX-1. And using tapered EPDM plugs in the tubes. Belzona 1391 was injected and allowed to flow around the EPDM plugs forming a new “ceramic base”, then plugs were removed after the material had cured.

This tube sheet was horizontally situated and contained 2300 tubes. Operating at 80°C, it was decided to use Belzona 1391. The use of tapered EPDM Plugs meant that each tube opening was conical and easy to remove once material had cured.
