BELZONA REPAIRS AND PROTECTS ERODED TUG BOAT KORT NOZZLES

ID: 5293

Eroded tug boat kort nozzles

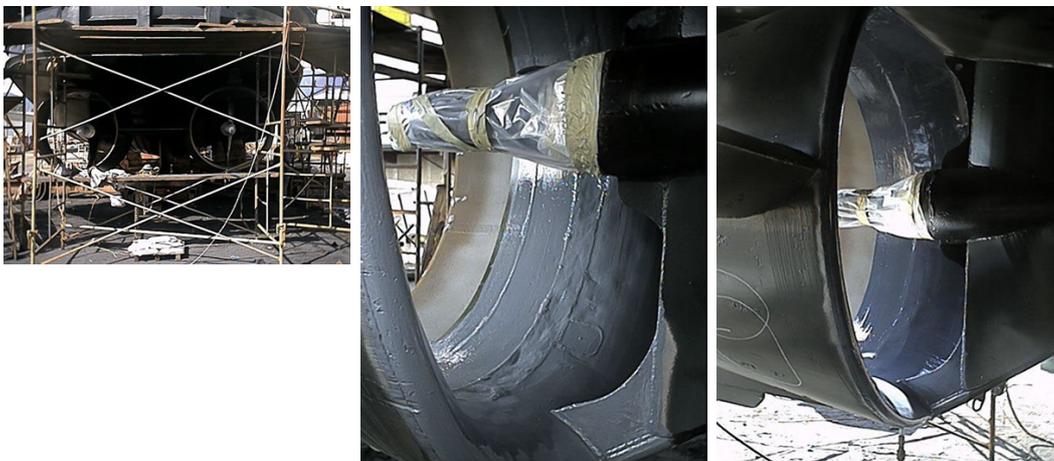
Bi-metallic corrosion had eroded much of the metal and welds adjoining the stainless steel insert positioned in the center of the nozzle.

- * View of vessel in dry dock ,
- * Repairs to eroded and damaged areas in progress ,
- * Completed application ,

The application was carried out in accordance with Belzona Know-How System Leaflets SOS-1 and SOS-2.

Tugs used for hauling log booms up and down the coastline. Original application had taken place in 1996. Sections of the kort nozzle had to be replaced because of excessive internal corrosion. Much of the original coating and rebuilt areas were still in good condition. The owner was happy to reapply Belzona once the new sections were in place and welding complete. Rebuilding the nozzles with Belzona 1311 eliminates excessive welding. Coating the repaired area with Belzona 1321 improves the abrasion resistance of the surfaces and eliminates bi-metallic corrosion.
