# BELZONA REPAIRS A CRUSHER'S BOWL LINER BASE

ID: 5297

Industry: *Mining & Quarrying*

Customer Location: *Mine, Chile*

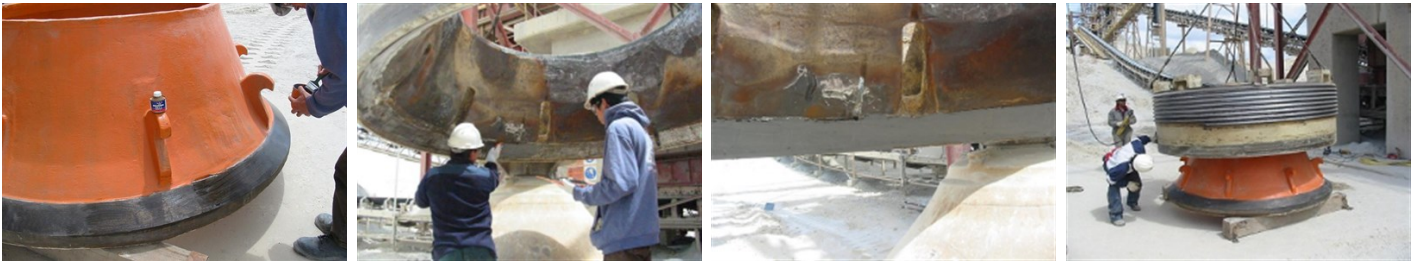
## Photograph Descriptions

*Movement and vibration at the base of the bowl liner caused wear and tear of the fastener on the bowl liner.*

- \* Application of Belzona 9411 on the area of the bowl liner ,
- \* Application of Belzona 1111 on the fastener of the base of the bowl liner ,
- \* Application of Belzona 1111 ,
- \* Installation of the fastener over the bowl liner ,

The damaged area on the base of the fastener of the bowl liner was cleaned. Belzona 9411 was applied on the bowl liner, Belzona 1111 was applied at the base of the fastener of bowl liner and the pieces were later joined, before Belzona 1111 could cure to make a mold.
