# A Window of Opportunity for Belzona

Application: WPA-Wall Problem Areas

Customer Location: Housing Authority - St. Helens, UK

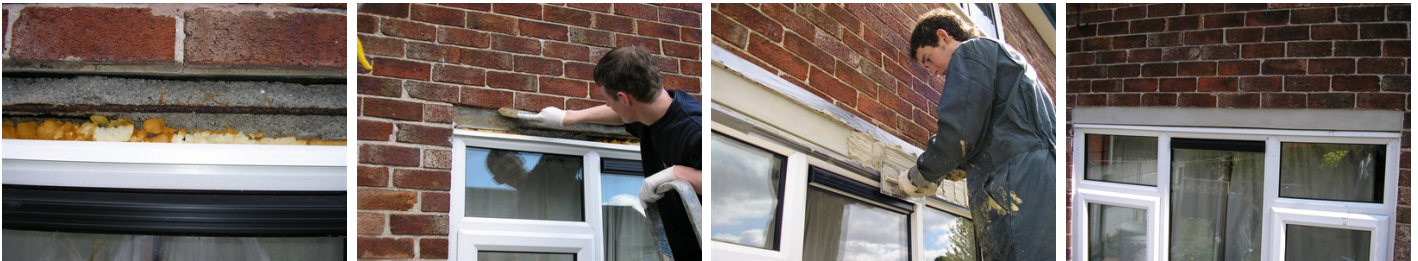
## Photograph Descriptions

The concrete lintels had spalled revealing the reinforcement bars underneath. The Housing Association were fitting new windows and wanted repairs carried out quickly and effectively.

- \* The damaged lintels ,
- \* The area being cleaned and prepared ,
- \* Belzona® 4141 being applied ,
- \* Finished lintel ,

Application was carried out in accordance with Belzona Know-How System Leaflet WPA-4.

The Belzona solution was chosen as the best way to effect very quick, simple repairs that could be done all at once without the need for formers to be left in place. The ability of Belzona to protect and resist further spalling was also a prime consideration of the client. Alternative was the use of traditional sand/cement mortars that would have looked poor, lacked performance and would have required a much wider time frame to complete. This scheme saw 20 lintels of around 2 metres each completed in under just three days.
