# BELZONA REBUILDS ERODED RUDDER PINTLE HOUSING

ID: 5301

Industry: *Marine*  
Application: *SOS-Ships and Offshore Structures*

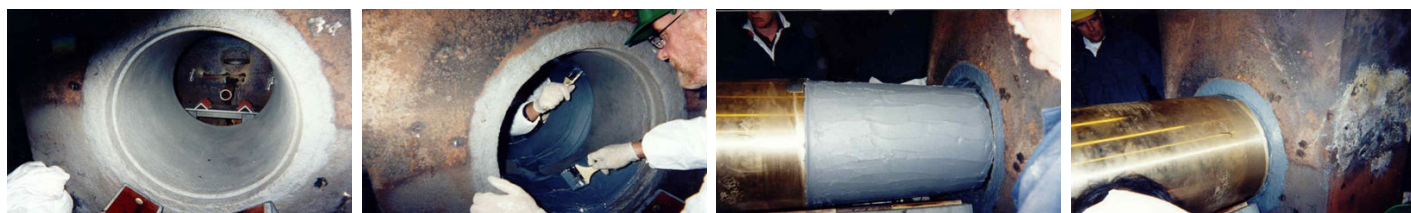
*Bi-metallic corrosion had eroded much of the metal (about ¼ inch) from the rudder pintle housing.*

- \* View of blasted rudder housing. ,
- \* Housing coated with Belzona 1321 to increase slip factor. ,
- \* Rudder in position on horizontal slide partially inserted. ,
- \* Rudder pintle inserted and allowed to set up before being removed with the aid of a 30 ton hydraulic jack. The reformed bore was inspected by the ships insurers and found to provide almost 100% contact. ,

The application was carried out in accordance with Belzona Know-How System Leaflet SOS-3.

Using Belzona eliminated the need for extensive welding and line boring. The application was completed in less than 12 hours.
