# BELZONA REPAIRS VOITH SCHNEIDER PROPULSION UNIT

ID: 5305

Customer Location: Ferry, Gourock, UK  
Application Date: September 2014

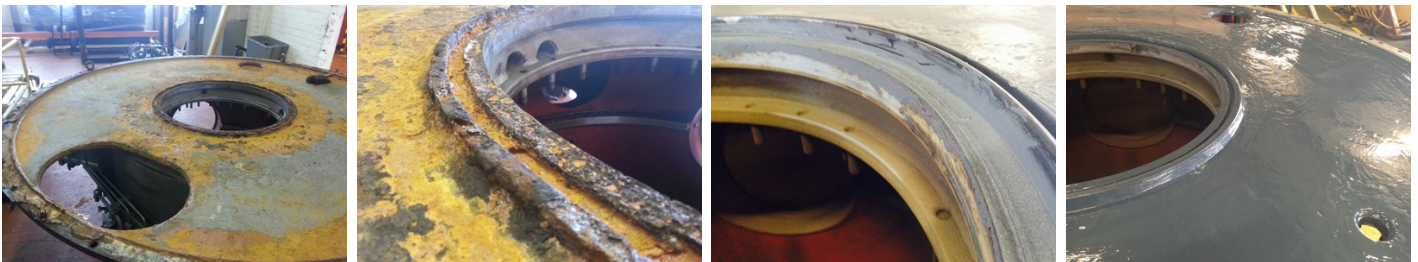
## Photograph Descriptions

*The combination of sea water and erosion from silt and sand was creating an erosion-corrosion cycle. Extensive metal loss had been noticed on the face of the equipment and on the inner rims.*

\* 1. Voith unit before work started 2. The damage on the inner rim 3. Belzona 1311 applied & former in place 4. Former removed, rim rebuilt and face coated with Belzona 1321 ,

The application was carried out in accordance with Belzona System Leaflets SOS-1 & 2. The unit was grit blasted and salt tested. The inner rim was then built up using a pre-fabricated metal former. The face was also built back up using Belzona 1311. Belzona 1321 was then applied to coat & protect the unit from future erosion/corrosion.
