Belzona Rebuilds & Protects Pump Impeller

ID: 531

Customer Location: Water Treatment Plant - UK
Application Date: February 2005

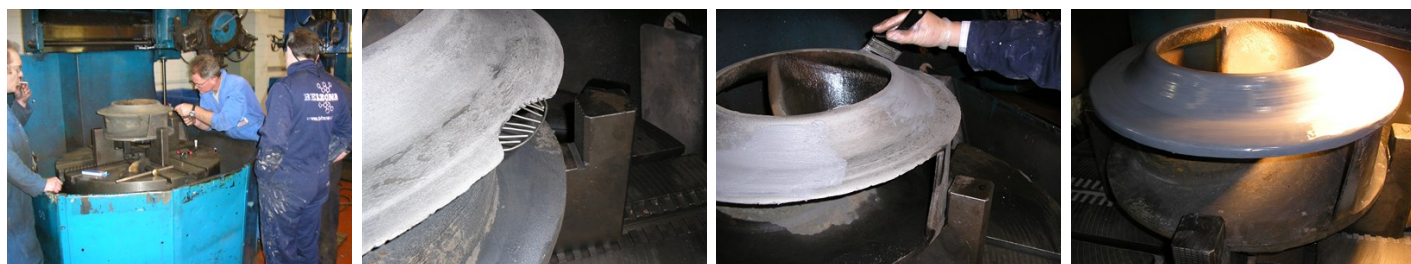
Photograph Descriptions

Impeller had moved on its shaft causing it to run against the casing. This resulted in severe abrasive wear and mechanical damage.

- * Impeller on vertical borer prior to cleaning and refurbishment ,
- * View of wear and mechanical damage. Wire framework was used to reinforce repair ,
- * Application of Belzona® 1111 underway ,
- * Completed impeller after application of final coats of Belzona® 1321 ,

Application was carried out in accordance with Belzona Know-How System Leaflets CEP-1 and CEP-3.

Previously, impellers in this condition were not considered repairable resulting in delivery lead times to source a new part as well as the associated replacement costs. The repair using Belzona meant the part could be returned to service within 48 hours.
