BELZONA PROTECTS NEUTRALIZATION PIT

ID: 5312

Customer Location: Corunna, ON, Canada
Application Date: August 2014

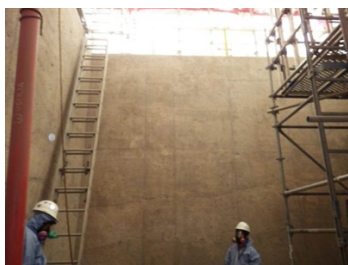
Existing rubber liner had torn, allowing the water, caustic and acid to attack the concrete substrate.

- * Prior to application ,
- * Rebuilt substrate ,
- * Application in progress ,
- * Completed application ,

The application was carried out in accordance with Belzona Know-How System Leaflet WPA-4 for rebuilding vertical and overhead masonry substrates, FPA-1 for rebuilding worn and damaged floor surfaces and TCC-15 for sealing and protecting containment areas. The walls were rebuilt with Belzona 4911 and Belzona 4141. The floor was rebuilt with Belzona 4911 and Belzona 4131. Protection was completed by spraying one coat of Belzona 5811 and two coats of Belzona 4311 by plural sprayer.
