BELZONA PROTECTS NEUTRALIZATION PIT

ID: 5312

Customer Location: *Corunna, ON, Canada*

Neutralization pit.

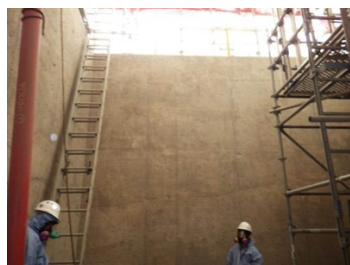
Existing rubber liner had torn, allowing the water, caustic and acid to attack the concrete substrate.

- * Prior to application ,
- * Rebuilt substrate ,
- * Application in progress ,
- * Completed application ,

The application was carried out in accordance with Belzona Know-How System Leaflet WPA-4 for rebuilding vertical and overhead masonry substrates, FPA-1 for rebuilding worn and damaged floor surfaces and TCC-15 for sealing and protecting containment areas. The walls were rebuilt with Belzona 4911 and Belzona 4141. The floor was rebuilt with Belzona 4911 and Belzona 4131. Protection was completed by spraying one coat of Belzona 5811 and two coats of Belzona 4311 by plural sprayer.
