# BELZONA'S SHAFT REPAIR RESTARTS PRODUCTION

ID: 5313

Industry: *General Industry*  
Application: *MPT-Mechanical Power Transmission*

Customer Location: *Petrolia, ON, Canada*  
Application Date: *August 2012*

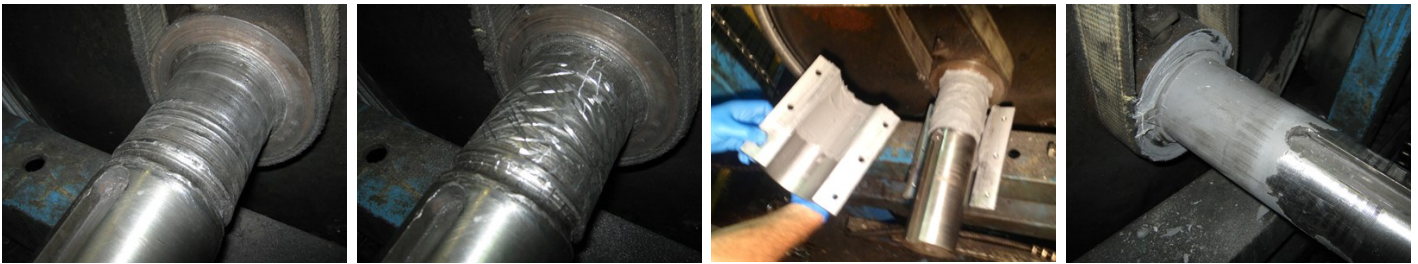
## Photograph Descriptions

*Shaft was worn and damaged.*

- \* Damaged shaft ,
- \* Completed preparation ,
- \* Application in process ,
- \* Completed application ,

The application was carried out in accordance with Belzona Know-How System Leaflet MPT-2 for rebuilding damaged shafts using forming techniques. The area was prepared using a disk grinder to roughen the surface and to make a cross-hatching pattern on the surface. A coat of Belzona 9411 was applied to the inside of the formers, and the edges where material will be pushed out. Belzona 1111 was applied to the shaft and covered the entire area using a brush and the mixing spatula to apply the product. Also, the inside of the formers were covered and evenly spread. The formers were clamped to the shaft. Once Belzona 1111 had cured the former was removed and the excess material was snapped off at the parting lines. Some of the material had flowed onto the shoulder of the shaft, but it was so thin that the area was sanded.
