BELZONA REPAIRS AND COATS RUBBER SOCK

ID: 5314

Application: *SHM-Solids Handling Machinery*

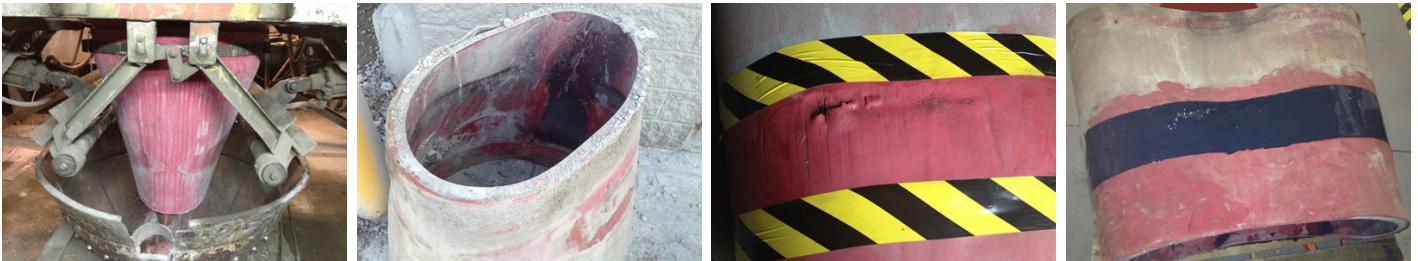
Photograph Descriptions

The rubber sock was worn.

- * Rubber sock ,
- * Prior to application ,
- * Complete preparation ,
- * Completed application ,

Rubber sock that dispenses concrete into the trucks.

The application was carried out in accordance with Belzona Know-How System Leaflet SHM-9 for creating and repairing rubber linings. The surface was prepared by removing any dirt or debris and cleaned. Belzona 2911 was applied to the prepared area and Belzona 2311 was applied with a brush. Belzona 2211 and Belzona 2221 were applied using a brush in accordance with Belzona Instructions For Use.
