BELZONA REPAIRS AND PROTECTS ROTOR FROM EROSION-CORROSION

ID: 5321

Vacuum pump rotor.

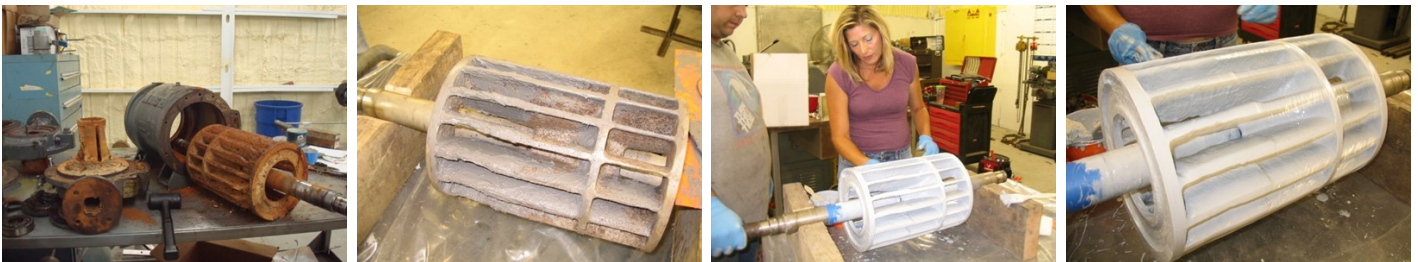
During the overhaul of this plant's Nash Vacuum Pump it was determined that the components were showing extreme signs of erosion and corrosion and could benefit from a Belzona renovation.

- * Vacuum pump recently taken out of service for repair ,
- * Pump prepped to a near white metal finish with steel slag ,
- * Technical Consultant assisting with the application ,
- * Completed application and the equipment is ready for installation ,

The contracted machine shop called us as the pump customer requested Belzona. The maintenance crew were trained, assisted and shown how to complete the repair to our rigid standards. The components were rebuilt with Belzona 1311 and protected with two coats of Belzona 1341; adhering to the custom engineering guidelines published in Belzona Know-How System Leaflets FBC-2 & FBC-15.
