BELZONA REPAIRS AIR HANDLING EQUIPMENT

ID: 5322

Application: MPT-Mechanical Power Transmission

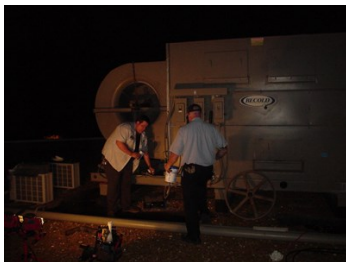
One of the bearings on this office building's air handler system failed and severely gouged into the fan's shaft. The cooling system was nearly crippled with a triple digit, Midwest July heat.

- * Air handler fan threw a bearing in the early a.m.; building without conditioned air for over 12 hours. ,
- * Customer secured the shaft for early a.m. repair. ,
- * Belzona repair completed before 6:00 a.m. ,
- * Completed application of shaft and ready to return to service that morning. ,

The shaft was supported and the pillow block was removed, exposing the damaged area. A suitable former was treated with Belzona 9411 and the bearing surface was roughened and degreased. Belzona 1111 was mixed and applied, then the form was clamped in place. After a short cure, a new bearing was installed and the air handler was placed back on-line. The application was carried out in accordance with Belzona Know-How System Leaflet MPT-2.
