# BELZONA REPAIRS AIR HANDLING EQUIPMENT

ID: 5322

Industry: Heating, Ventilation & Air Conditioning  
Application: MPT-Mechanical Power Transmission

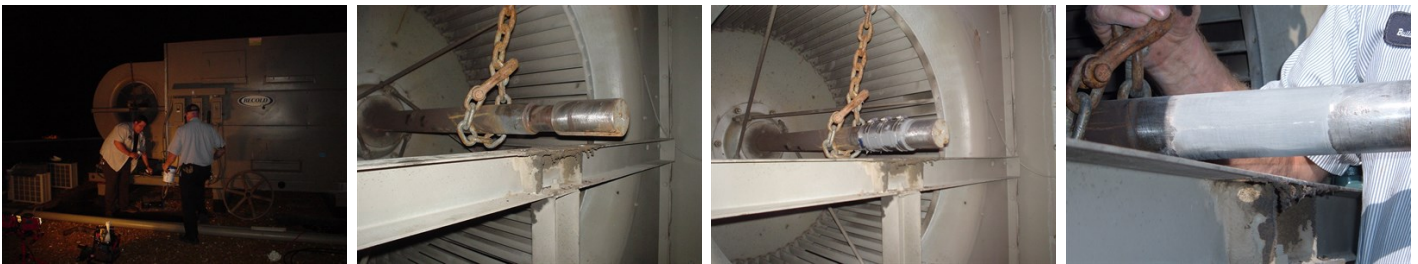
One of the bearings on this office building's air handler system failed and severely gouged into the fan's shaft. The cooling system was nearly crippled with a triple digit, Midwest July heat.

- \* Air handler fan threw a bearing in the early a.m.; building without conditioned air for over 12 hours. ,
- \* Customer secured the shaft for early a.m. repair. ,
- \* Belzona repair completed before 6:00 a.m. ,
- \* Completed application of shaft and ready to return to service that morning. ,

The shaft was supported and the pillow block was removed, exposing the damaged area. A suitable former was treated with Belzona 9411 and the bearing surface was roughened and degreased. Belzona 1111 was mixed and applied, then the form was clamped in place. After a short cure, a new bearing was installed and the air handler was placed back on-line. The application was carried out in accordance with Belzona Know-How System Leaflet MPT-2.
