BELZONA REINFORCES AND PROTECTS TURBINE

ID: 5323

Application: CEP-Centrifugal Pumps

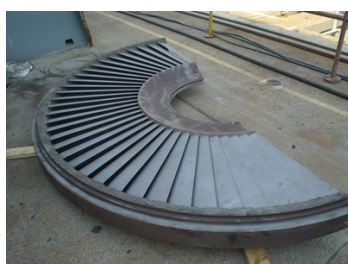
The GE Turbine was partially disassembled for inspection. 7th stage blades being replaced in HP turbine section. Stationary diaphragms of last two stages of LP turbine section were removed for inspection and it was determined that they had been rebuilt with Belzona 1311 two outages prior (16 years ago!). The customer wanted to ensure many more years of service.

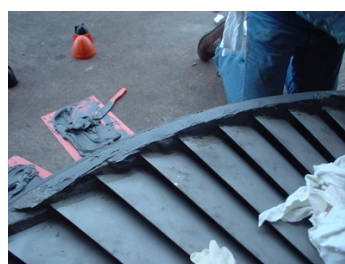
- * Overview of the Power Plant ,
- * Stationary diaphragms removed for inspection ,
- * Blades showed signs of erosion so they were rebuilt ,
- * Application carried out for all four diaphragm halves showing one of the four finished repairs ,

Only one power pack of Belzona 1311 was needed to repair four diaphragm halves and four casing bells. The application was carried out in accordance with Belzona Know-How System Leaflet CEP-1.
