BELZONA REPAIRS DAMAGED SHAFT

ID: 5325

Industry: Heating, Ventilation & Air Conditioning
Application: MPT-Mechanical Power Transmission

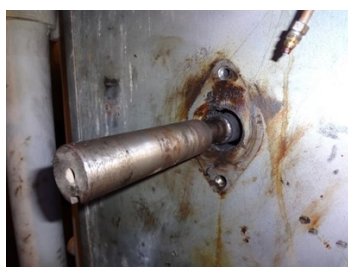
Bearing failure on the air handler for the main lobby of this busy downtown hotel wore into the shaft so severely that the cooling system was out of commission as the Spring weather was heating up.

- * Hotel storefront ,
- * Damaged shaft ,
- * Consultant assisting staff engineer with Belzona 1111 ,
- * Completed application ,

Air handler bearing failed, gouging shaft.

A trained machine shop fabricated a split former to the exact dimensions and the shaft was quickly repaired in-situ with Belzona 1111. The application was carried out in accordance with Belzona Know-How System Leaflet MPT-2.
