BELZONA REBUILT MARINE JET DRIVE PROPULSION UNITS

ID: 5327

Jet drive propulsion units

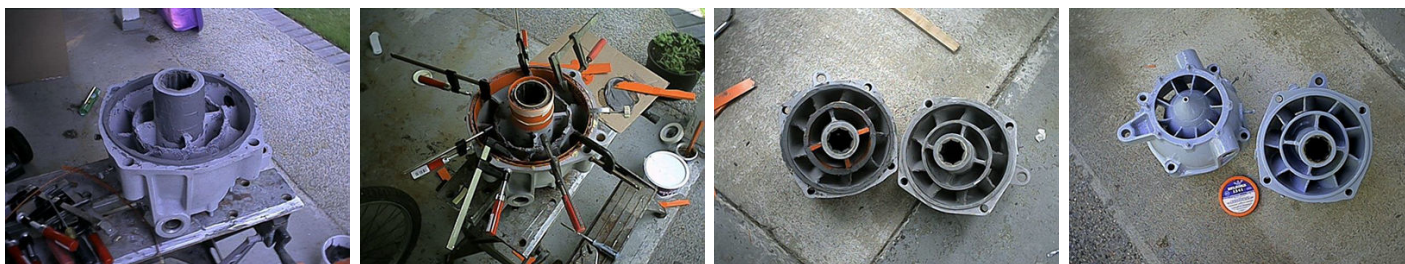
Photograph Descriptions

Bi-metallic corrosion had eroded much of the metal despite the placement of sacrificial zinc anodes on side of units.

- * Units after blasting showing extent of erosion with center and outer locating ring rebuilt. ,
- * Rebuild of other areas in progress using flexible plastic forms and G-clamps. ,
- * All rebuilding completed with filing and sanding in progress to ensure smoothness. ,
- * Application completed with units protected with 2 coats of Belzona 1341. ,

The application was carried out in accordance with Belzona Know-How System Leaflets CEP-3 and CEP-5.
