# BELZONA REPAIRS DRESSER COUPLING

ID: 5329

Application Date: *December 2009*

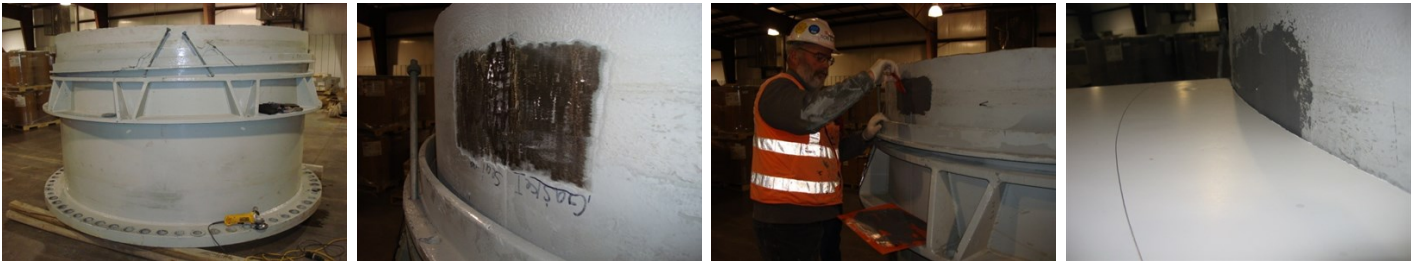
## Photograph Descriptions

*The newly fabricated fitting had a slightly flat spot at the joining weld that would not allow a complete seal with the dresser coupling.*

- \* Dresser coupling ,
- \* Low spot showing prepared surface ,
- \* On-Site Contractor applying Belzona 1111 ,
- \* Completed application ,

The area of concern was identified and ground to bare metal with a rough finish. The flat area was then rebuilt with Belzona 1111. The proper contour was verified by using a suitable template.
