# BELZONA REPAIRS DRESSER COUPLING

ID: 5329

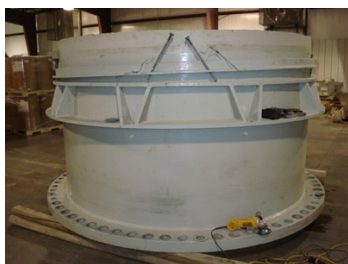
- \* Dresser coupling ,
- \* Low spot showing prepared surface ,
- \* On-Site Contractor applying Belzona 1111 ,
- \* Completed application ,

Dresser coupling out of service because it would not seal properly.

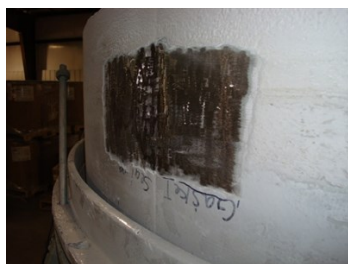
The newly fabricated fitting had a slightly flat spot at the joining weld that would not allow a complete seal with the dresser coupling.

The area of concern was identified and ground to bare metal with a rough finish. The flat area was then rebuilt with Belzona 1111. The proper contour was verified by using a suitable template.
