BELZONA EXTENDS THE LIFE OF THE ROOF

ID: 5332

Customer Location: *Great Falls, MT, USA*
Application Date: *1986*

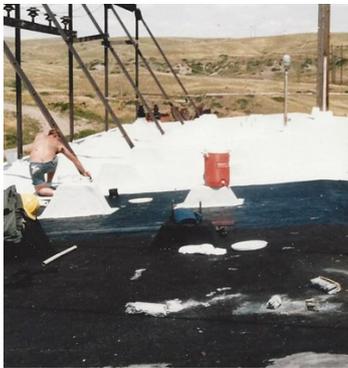
- * Roof half done, showing the complicated design and many protrusions ,
- * Belzona 9311 laid out and brushing on Belzona 3111 ,
- * & 4. Completed application ,

The power was cut to sections of the roof where we worked. The roof was dry brushed to remove dirt in the alligator cracks. Because the lines below the roof and overhead carried high voltage electricity, we were not allowed to use water. Belzona 3911 was brushed and rolled on all tar areas while Belzona 3921 was applied to the prepared metal bases, insulators and copper flashings around the roof edges. Belzona 9311 was laid out and the first coat of Belzona 3111 was applied with long handle brushes. The

second coat was brushed on the same day. The work began at one end of the roof taking 5 days to complete the job. Temperatures were over 100F on the roof. It is now 2014 and the roof has been leak free for 28 years. The application was carried out in accordance with Belzona Know-How System Leaflets RPA-1, RPA-6 & RPA-8.
