BELZONA EXTENDS THE LIFE OF THE ROOF

ID: 5332

Customer Location: Great Falls, MT, USA
Application Date: 1986

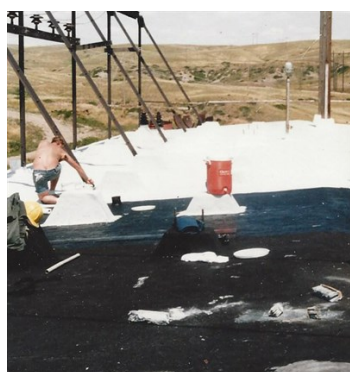
This roof had leaked for as long as they could remember. One person speculated that it had probably leaked since it had been built, which was 1906. You can see the many protrusions through the roof, making it difficult to seal with conventional roofing products. Currently, the hot-mopped tar on the roof was seriously "alligatored".

- * Roof half done, showing the complicated design and many protrusions ,
- * Belzona 9311 laid out and brushing on Belzona 3111 ,
- * & 4. Completed application ,

The power was cut to sections of the roof where we worked. The roof was dry brushed to remove dirt in the alligator cracks. Because the lines below the roof and overhead carried high voltage electricity, we were not allowed to use water. Belzona 3911 was brushed and rolled on all tar areas while Belzona 3921 was applied to the prepared metal bases, insulators and copper flashings around the roof edges. Belzona 9311 was laid out and the first coat of Belzona 3111 was applied with long handle brushes. The

second coat was brushed on the same day. The work began at one end of the roof taking 5 days to complete the job. Temperatures were over 100F on the roof. It is now 2014 and the roof has been leak free for 28 years. The application was carried out in accordance with Belzona Know-How System Leaflets RPA-1, RPA-6 & RPA-8.
