BELZONA REPAIRS PILLOW BLOCK SHAFT

ID: 5335

Industry: *Pulp & Paper*
Application: *MPT-Mechanical Power Transmission*

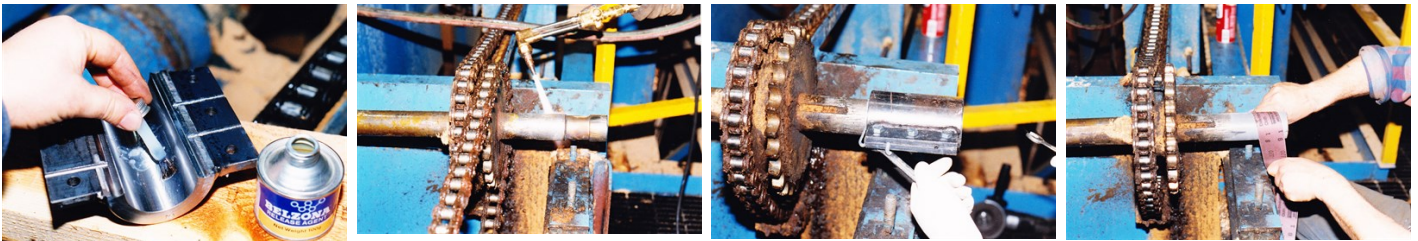
Photograph Descriptions

- * Applying Belzona 9411 to the former ,
- * Sweating the oil out of the steel shaft using a torch ,
- * Bolting the former in place ,
- * Dressing down Belzona 1111 with emery cloth ,

A former was made at the in-house machine shop in accordance with a modified version of Belzona Know-How System Leaflet MPT-2. Note the relief grooves down the side of the flanges. The former received two coats of Belzona 9411, then Belzona 1111 was applied. The shaft was ground and Belzona 1111 was applied. The former was bolted in place and Belzona 1111 was allowed to cure. After 2 hours, the former was removed, the excess of Belzona 1111 was dressed down with emery cloth and the new bearing installed.
