# BELZONA SAVES GENERATOR EQUIPMENT FROM WATER DAMAGE

ID: 5339

Industry: Power  
Application: RPA-Roof Problem Areas  
Substrate: Concrete, Steel and Aluminum  
Products: \* Belzona 3111 (Flexible Membrane) ,

Customer Location: WA, USA  
Application Date: 1993

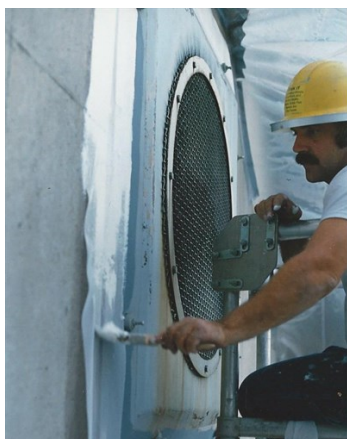
*The spillways at this dam shoot the water up into the air, causing the spray to wet the outside walls of the emergency generator room. The water enters from all of the construction joints as well as the exhaust vent.*

- \* Inside the emergency generator room ,
- \* Applying Belzona 3111 on the outside wall ,
- \* Applying Belzona 3111 on the outside wall ,
- \* Emergency generator room seen from across the river. The entire powerhouse is inside the mountain. ,

The application was carried out according to Belzona Know-How System Leaflet RPA-1 in order to seal all of the construction joints and the exhaust pipe.

Water entry was beginning to damage the emergency generator inside. Sealing all the water out saved the equipment inside. 21
