# Belzona: Sweet Success for Chocolate Manufacturer

Industry: *Commercial Facilities*  
Application: *SHM-Solids Handling Machinery*

Customer Location: *Snack Food Producer in Serbia*  
Application Date: *January 2004*

Substrate: *Carbon steel*  
Products: *\* Belzona® 4111 (Magma-Quartz),*

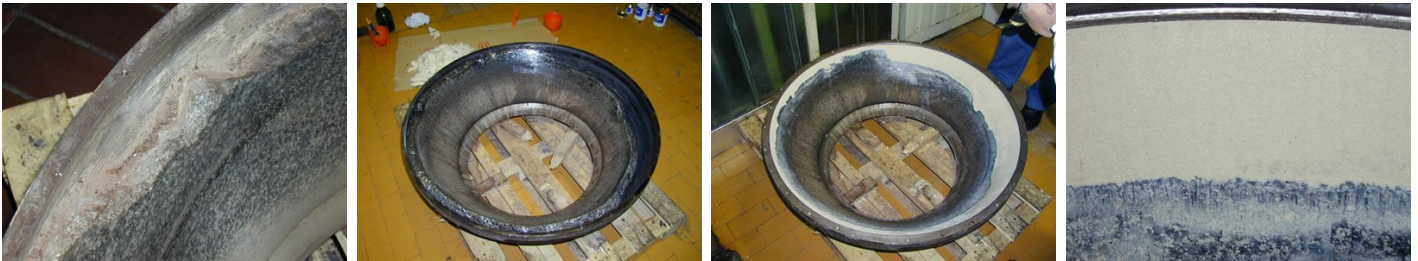
*Damaged lining caused by impact through years of service.*

- \* Close-up of damaged lining ,
- \* Mechanically prepared surface ready for Belzona ,
- \* Completed application ,
- \* Close-up of repaired lining detail ,

Granite lining (35-mm thick) on a chocolate mixing vessel.

Application was carried out in accordance with Belzona Know-How System Leaflet SHM-13.

Replacement costs on this piece of equipment were about €20,000 (\$16,000). The cost to repair the lining utilizing Belzona costs only €1,000 (\$1,200). The lining repaired with Belzona was in excellent condition after one year in service, and looks to provide many more years of cost-effective service. The customer has given Belzona the opportunity to protect other production vessels for long-term reliability and cost savings.
