# BELZONA IMPROVES PUMP EFFICIENCY

ID: 5341

Industry: Fluid Flow  
Application: CEP-Centrifugal Pumps  
Substrate: Cast Iron  
Products: \* Belzona 1341 (Supermetalgilde) ,

Customer Location: Washington, USA  
Application Date: 1993

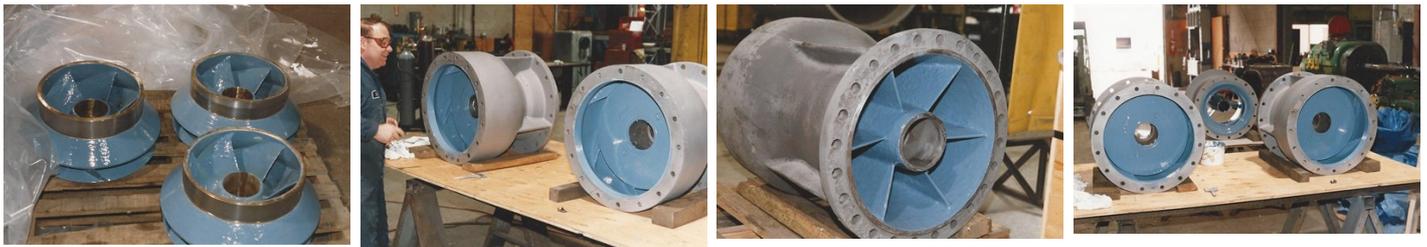
## Photograph Descriptions

- \* Completed application on impeller ,
- \* Completed application on casing ,
- \* Completed application on casing ,
- \* View of completed application on water pumps ,

The pump casings and impellers were grit blasted and then two coats of Belzona 1341 were applied. The application was carried out in accordance with Belzona Know-How System Leaflets CEP-10.
