# BELZONA REPAIRS AND PROTECTS TAPERED SHAFT

ID: 5345

Bull dozer final drive shaft.

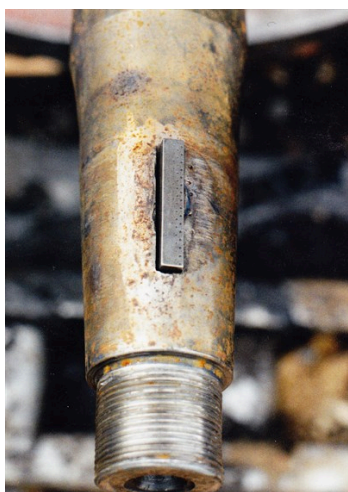
*The tapered final drive shaft keyway was worn oversize and the shaft was worn down.*

- \* Tapered drive shaft showing wear on the keyway ,
- \* Shaft and keyway prepared and Belzona 1111 applied ,
- \* New tapered hub in place centering the key ,
- \* Bull dozer partially disassembled ,

Application was carried out in accordance with Belzona Know-How System Leaflet MPT-4. The keyway and tapered shaft was ground to roughen the surface. Belzona 9411 was applied to the new key and the new hub. Belzona 1111 was applied and the hub was mounted in place to center the key. The excess of Belzona 1111 was removed. After the cure, the machine was reassembled.
