BELZONA QUICKLY REPAIRS CONVEYOR BELT

ID: 5347

Industry: General Industry
Application: SHM-Solids Handling Machinery

Customer Location: Lewiston, ID, USA
Application Date: 1992

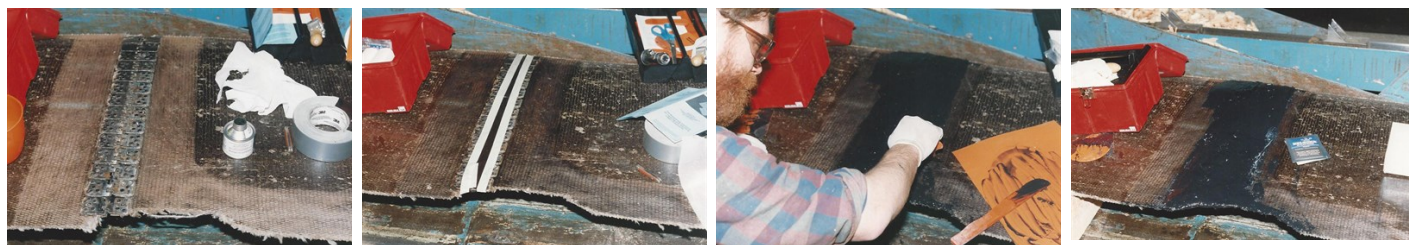
Photograph Descriptions

One of the joining clips came apart, hooked on the structure and tore away a piece of the belt. If it was left alone, it was likely to continue tearing.

- * Conveyor belt with area roughened ,
- * Bond breaker over the clips to allow movement and conditioner on the belt ,
- * Applying Belzona 2311 over the damaged area ,
- * Finished conveyor and ready for service ,

The belt was roughened and Belzona 2911 was applied and allowed to cure. A bond breaker was taped over the joint clips to allow movement. Belzona 2311 was mixed and applied with Belzona 9341 to coat the joint and seal the damaged area. The application was carried out in accordance with Belzona Know-How System Leaflet SHM-4.
