Rig Ballast System Repaired with Belzona

ID: 535

Severely corroded and leaking pipes in many sections of the ballast system which threaten the safety of the rig.

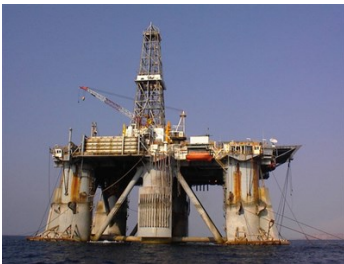
- * General view of the rig ,
- * Leakage of the ballast pipes of the rig ,
- * Repair completed ,
- * Another repair ,
