BELZONA PROTECTS STERN TUBE

ID: 5353

Stern tube in a US Army Ship.

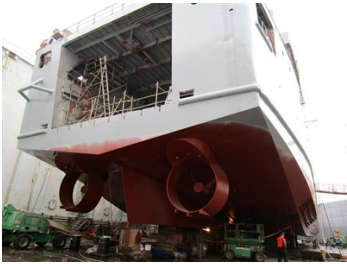
- * Stern of the ship ,
- * Inspecting the grit blast ,
- * First coat of black Belzona 5811 ,
- * Second coat of gray Belzona 5811 ,

The stern tube was grit blasted and then two coats of Belzona 5811 were brushed on. The application was carried out in accordance with Belzona Know-How System Leaflet SOS-2.
