BELZONA PROTECTS STERN TUBE

ID: 5353

Industry: Marine
Application: SOS-Ships and Offshore Structures

Stern tube in a US Army Ship.

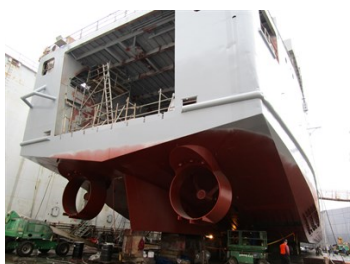
- * Stern of the ship ,
- * Inspecting the grit blast ,
- * First coat of black Belzona 5811 ,
- * Second coat of gray Belzona 5811 ,

The stern tube was grit blasted and then two coats of Belzona 5811 were brushed on. The application was carried out in accordance with Belzona Know-How System Leaflet SOS-2.
