WATER PUMPS REPAIRED AT HISTORIC RESERVOIR

ID: 5357

Customer Location: Queen Mary Reservoir, Surrey
Application Date: August 2014

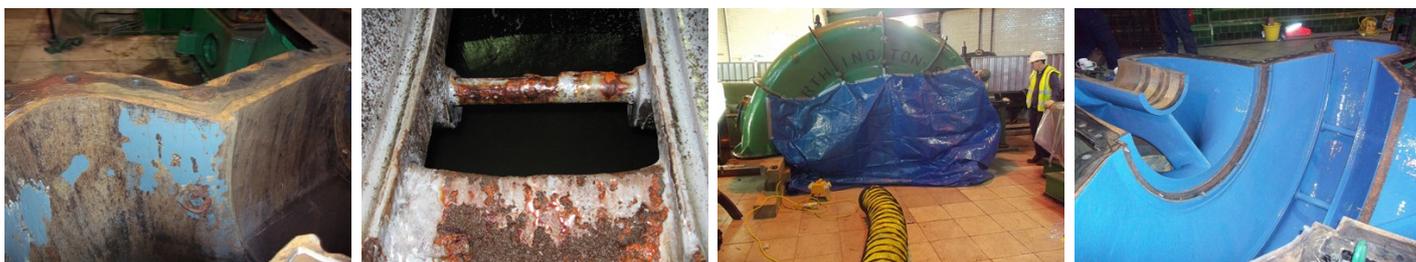
Photograph Descriptions

After years of frequent use, certain areas of the pumping equipment were suffering from cavitation damage, which in turn was seriously hindering the efficiency of the pumping system.

- * Pump casing prior to removal of existing coating ,
- * Pump casing severely corroded ,
- * Sponge blasting in progress ,
- * Completed application ,

Damaged pump volutes, totalling a surface area of 282m².

Application carried out in accordance with a modified version of Belzona Know-How System Leaflet CEP-3. Firstly, Sponge Blasting equipment was used on the upper and lower casings to remove the previous coating and create a cleanliness of at least SA 2 ½ and produce a surface profile of no less than 75µm. Due to the extent of the damage, (some areas of each volute exhibited up to 50% corrosion) complete metal repairs were prescribed using Belzona 1111 followed by a protective coating of Belzona 1341.
