# WATER PUMPS REPAIRED AT HISTORIC RESERVOIR

ID: 5357

**Customer Location:** Queen Mary Reservoir, Surrey  
**Application Date:** August 2014

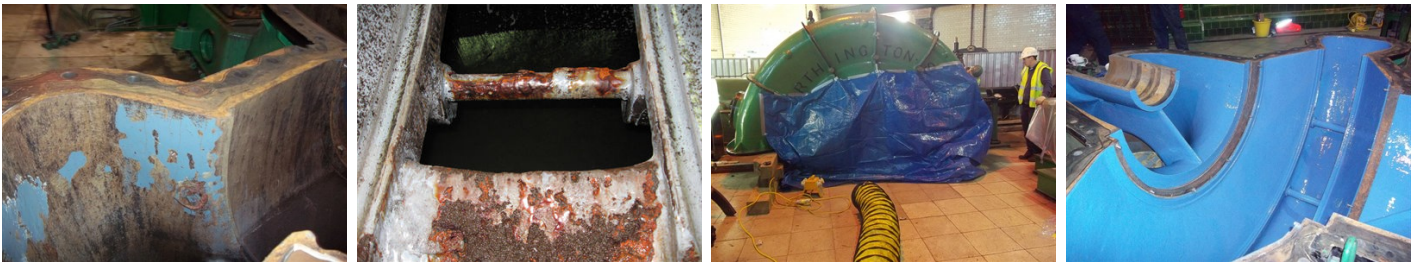
After years of frequent use, certain areas of the pumping equipment were suffering from cavitation damage, which in turn was seriously hindering the efficiency of the pumping system.

- \* Pump casing prior to removal of existing coating ,
- \* Pump casing severely corroded ,
- \* Sponge blasting in progress ,
- \* Completed application ,

Damaged pump volutes, totalling a surface area of 282m<sup>2</sup>.

Application carried out in accordance with a modified version of Belzona Know-How System Leaflet CEP-3. Firstly, Sponge Blasting equipment was used on the upper and lower casings to remove the previous coating and create a cleanliness of at least SA 2 ½ and produce a surface profile of no less than 75µm. Due to the extent of the damage, (some areas of each volute exhibited up to 50% corrosion) complete metal repairs were prescribed using Belzona 1111 followed by a protective coating of Belzona 1341.

Belzona 1341 was specified as it will provide long-term erosion and corrosion protection of the equipment and improve the operating efficiency of the pump. It does this by using hydrophobic technology which repels process fluids, reducing surface friction
