# BELZONA REPAIRS STEERING GEAR

ID: 536

Customer Location: *Cargo Ship - Egypt*  
Application Date: *December 2003*

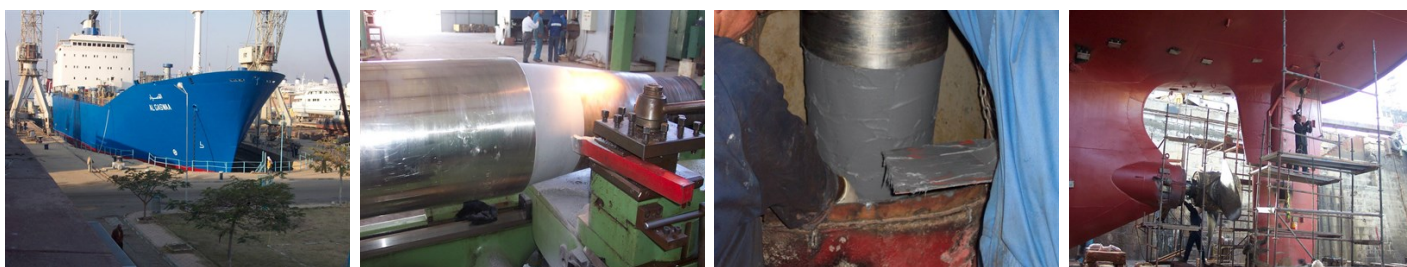
## Photograph Descriptions

*Severe corrosion on the affected areas of the rudder stock and pintle housing areas.*

- \* General view of the cargo ship. ,
- \* Rudder stock being machined back to its dimensions after repair. ,
- \* Belzona® 1121 was applied to both pintle and pintle housing. ,
- \* Rudder being installed. ,

Rudder stock - upper housing and pintle housing.

Application was carried out in accordance with Belzona Know-How System Leaflets SOS-3 and MPT-1.
