Belzona coating for a chemical tank

ID: 5361

Customer Location: Lavéra, France
Application Date: 2012

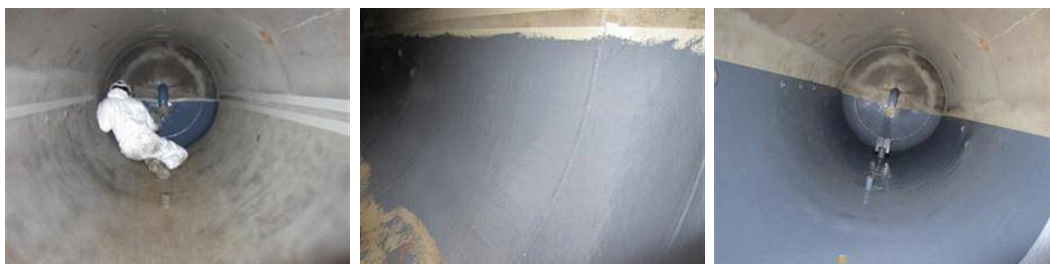
Photograph Descriptions

Steel without protection can be easily attacked by chemicals stored in the tank at 105°C.

- * Tank after blasting, ,
- * Beginning of the application ,
- * On-going application of the coating Finished application ,

The application was done in accordance to Belzona system leaflet TCC-5. After degreasing and blasting the surface, Belzona 1391 was applied in a one coat system (600 to 750µm) on the bottom part of the tank.
