BELZONA REBUILDS PUMP IMPELLER

ID: 5365

Application: *CEP-Centrifugal Pumps*

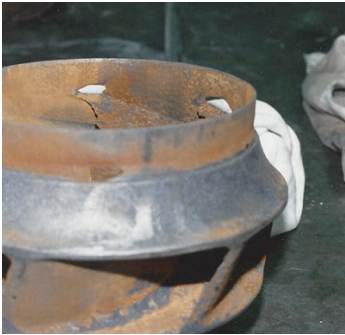
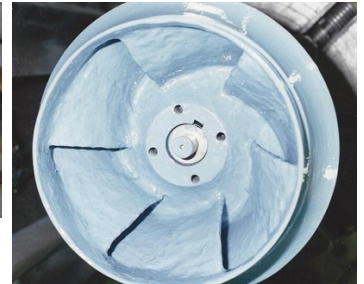
The pump had become worn beyond repair and was thus tossed in a scrap pile.

- * Damaged impeller showing holes ,
- * Worn impeller vanes ,
- * Impeller rebuilt with Belzona 1311 ,
- * Completed application with two coats of Belzona 1341 ,

The application was carried out in accordance with Belzona Know-How System Leaflets CEP 1 & CEP 3. Holes and impeller vanes were patched with Belzona 1311 and a reinforcing sheet. The high spots were ground down to smooth the surface and Belzona 1341 was brushed on in two coats.
