# BELZONA STOPS LUBE LEAKS

Industry: Oil & Gas  
Application: FPA-Floor Problem Areas  
Substrate: Concrete  
Products: \* Belzona 5811 (Immersion Grade) ,  
\* Belzona 9331 (Reinforcing sheet) ,

Customer Location: Beaumont, Texas, USA  
Application Date: April 2014

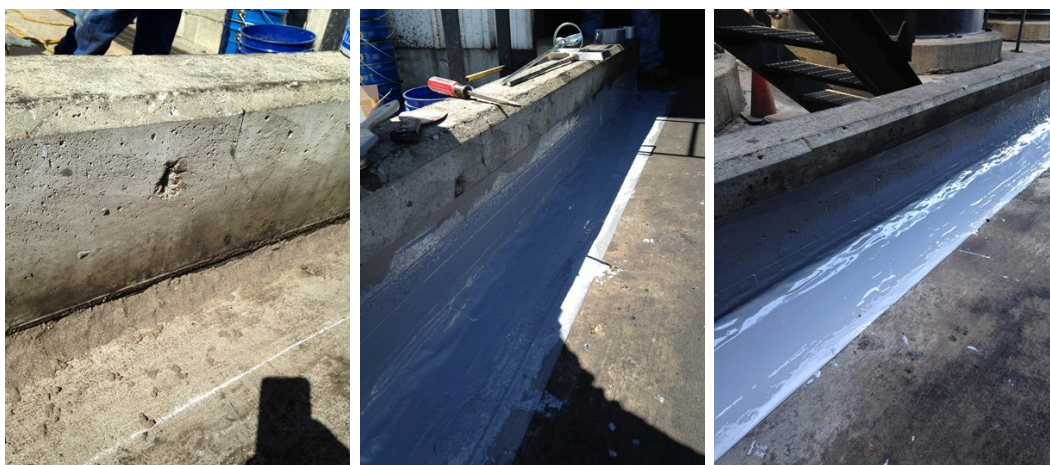
The customer stored lube oil within a small containment area, when leaks would develop they would by-pass and go under the wall onto the ground outside of the containment area.

- \* Before repair ,
- \* During repair ,
- \* Application completed ,

Concrete wall leaking lube oil

Application was carried out in accordance with a modified version of Belzona Know-How System Leaflet FPA-3.

the Belzona application keeps the lube within the containment for easy clean-up.
