Belzona repairs crude oil leaks

ID: 5376

Customer Location: Houston, Texas, USA
Application Date: November 2013

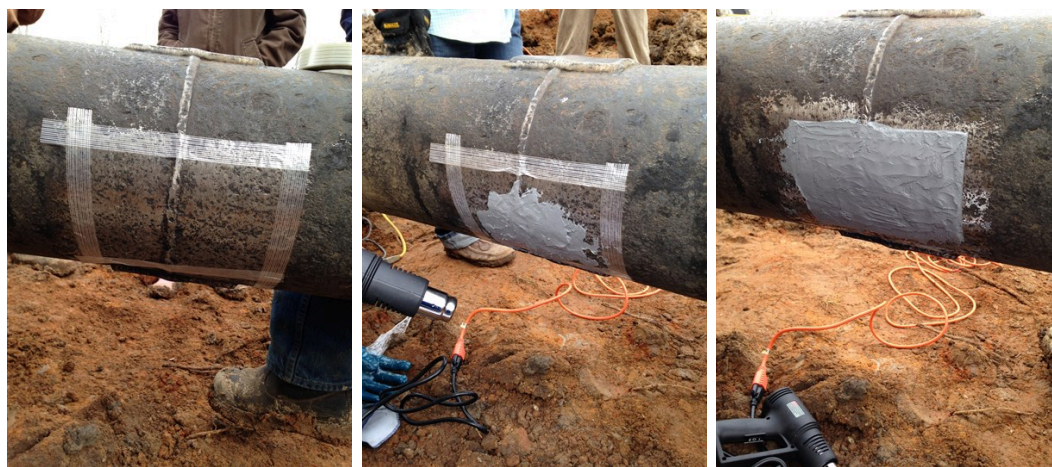
Photograph Descriptions

After testing a newly installed line, the customer found a pinhole leak at a weld. Hot work was not permitted because crude oil was now in the line.

- * Cleaning of the immediate area ,
- * Belzona 1221 was used to stop leak ,
- * Belzona 1161 used to encapsulate for long term protection ,

Pinhole leak at weld on a crude oil line.

The application was carried out using a modified version of Belzona Know-How System Leaflet VPF-11. Belzona 1221 was used to stop the immediate leak. The area surrounding the leak was then prepared and Belzona 1161 was applied for long term protection.
