# BELZONA REPAIRS A 40-YEAR OLD IRRIGATION PUMP

Application: CEP-Centrifugal Pumps

40-year old 5-stage irrigation pump.

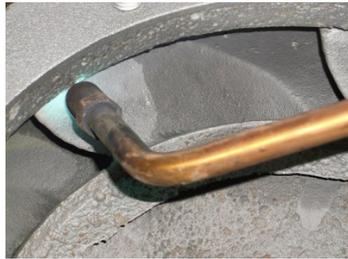
Pump had decreased productivity. It has not been pulled since it was installed in 1974.

- \* 1. Damaged pump bowl and impeller ,
- \* 2. Sweating the bowl prior to blasting ,
- \* 3. All 5 impellers completed ,
- \* 4. Two of the bowls and suction pipe completed ,

All surfaces to be coated were properly grit blasted to a near white finish. The parts were washed down with a non-chlorinated cleaner. Areas of extreme pitting or cavitation were repaired using Belzona 1221. The first coat of Belzona 1341 was then applied, with the second coat being applied the following day. Applications was carried out in accordance with Belzona Know-How System Leaflets CEP-1 & CEP-10.
