# BELZONA ENCAPSULATES A TRANSFORMER FAUCET

ID: 5381

**Industry:** Power  
**Application:** VPF-Valves, Pipes and Fittings  
**Substrate:** Brass and steel  
**Products:** \* Belzona 1291 (ES-Metal) ,  
\* Belzona 1161 (Super UW-Metal) ,

**Customer Location:** Lewiston, ID, USA  
**Application Date:** May 2014

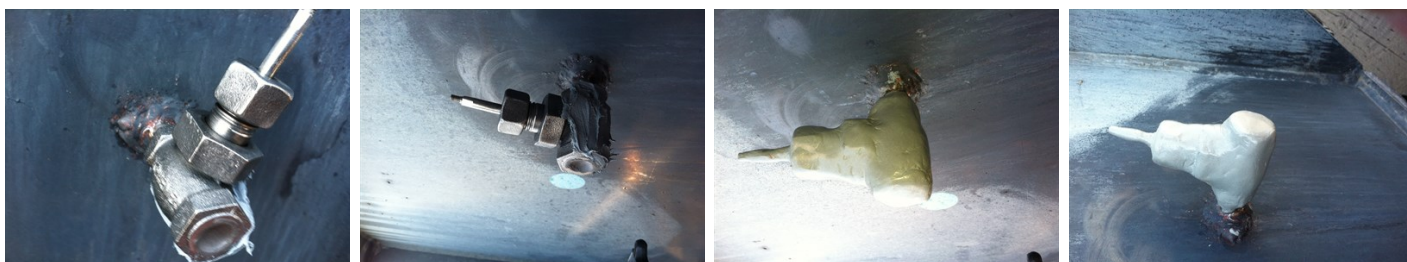
## Photograph Descriptions

*This leaking faucet was no longer needed, but in order to replace or plug it, the transformer would have to be taken off line and the entire 2000 gallons of oil would need to be drained resulting in lost revenue for this power company.*

- \* 1. Prepared surface ,
- \* 2. Belzona 1291 applied in the end ,
- \* 3. Applying Belzona 1161 ,
- \* 4. Application completed ,

Leaking inspection faucet.

The faucet was prepared with a grinder, then the active leak was stopped and sealed using Belzona 1291. Belzona 1161 was then used to encapsulate the entire faucet. Application was carried out in accordance with Belzona Know-How System Leaflet VPF-11.
