BELZONA FIXES BAD WELDS ON A TRANSFORMER

ID: 5383

Customer Location: Lewiston, ID, USA
Application Date: May, 2014

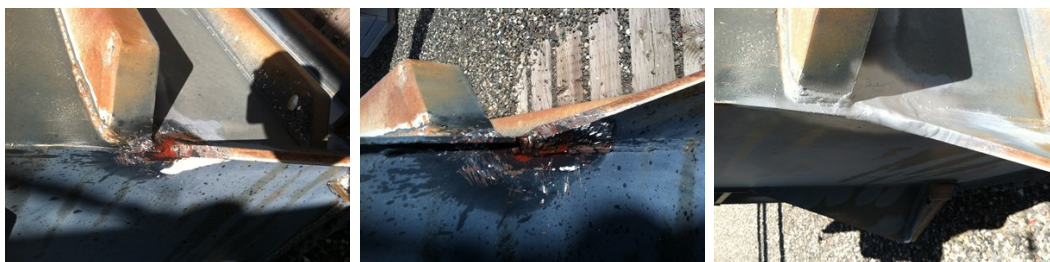
Corner bracket on an active electrical transformer was leaking oil.

- * 1. View of the leaking weld ,
- * 2. Side view of the leaking weld, including the oil stain surrounding the weld ,
- * 3. Application completed ,

Leaking corner weld on an active transformer.

The surface was prepared using a coarse grit grinding wheel. The Belzona 1161 was applied according to the Instructions For Use. Application was carried out in accordance with a modified version of Belzona Know-How System Leaflet TCC-1.

The repair needed to be made without taking the transformer off-line which uses excessive labor and resources and results in money loss from not operating. Belzona 1161 allows for potential oil or water residue on the surface at the time of application which is necessary when trying to repair transformer oil leaks with it still being online.
