# Belzona Repairs Vacuum Pump

Customer Location: Large Phosphate production facility - Egypt

Application: CEP-Centrifugal Pumps

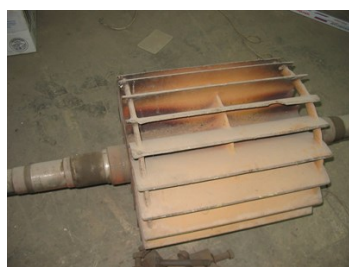
Eroded-corroded rotor and casing due to the effect of water, chemicals and limestone. The vanes of the rotor were cracked and fractured in many places.

- \* The eroded-corroded rotor ,
- \* Repairs to cracks and fractures in the vanes of the rotor ,
- \* Rotor after repairing and coating. ,
- \* Casing after repairing and coating ,

The application was carried out in accordance with Belzona® Know-How System Leaflets CEP-1 and CEP-3.
